**IP65 and Pressure Drop Tests on a
Spraydown Solutions in Conjunction
with Engineered Air Treatment
Louvre with a G4 Panel Filter**

File Reference: 67_2020TM

Confidential Technical Report for Spraydown Solutions Ltd

IP65 and Pressure Drop Tests on a Spraydown Louvre with a G4 Panel Filter

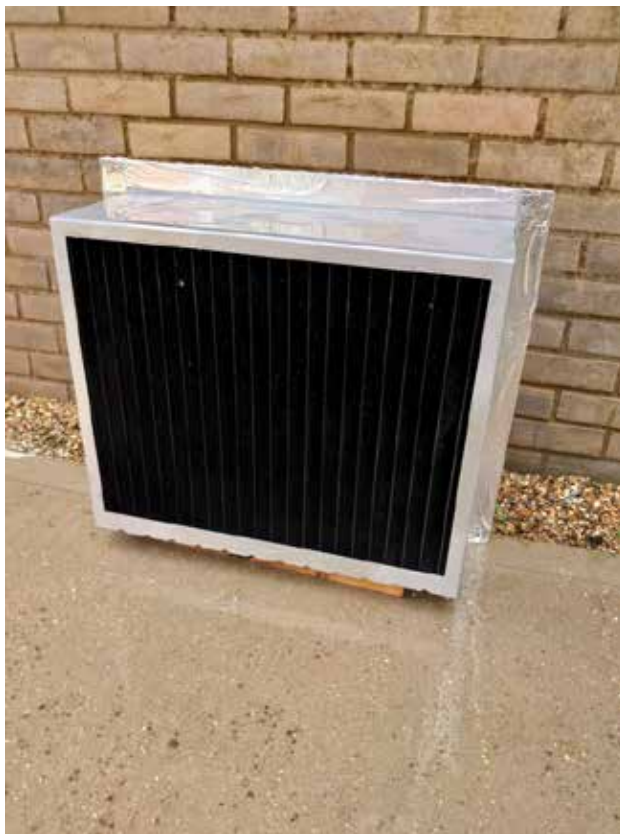
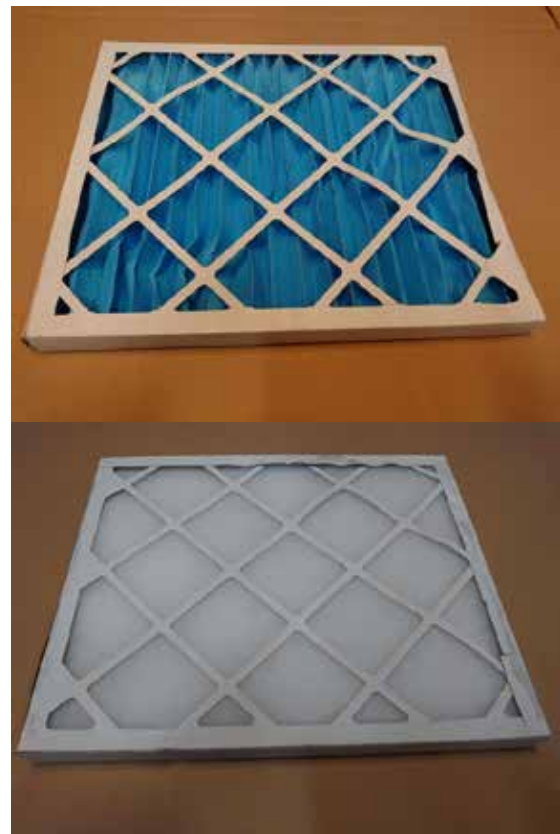
Figure 1: SD₂ PVC Profile & Filters

The details of the louvre and filter can be found in table 1 and figure 1 shows the louvre prior to testing.

Model / Type	SD ₂ PVC Profile
Dimensions (mm)	525 x 620 x 230
Material	PVC
Filter Types	Synthetic & Pleated G4 Panel

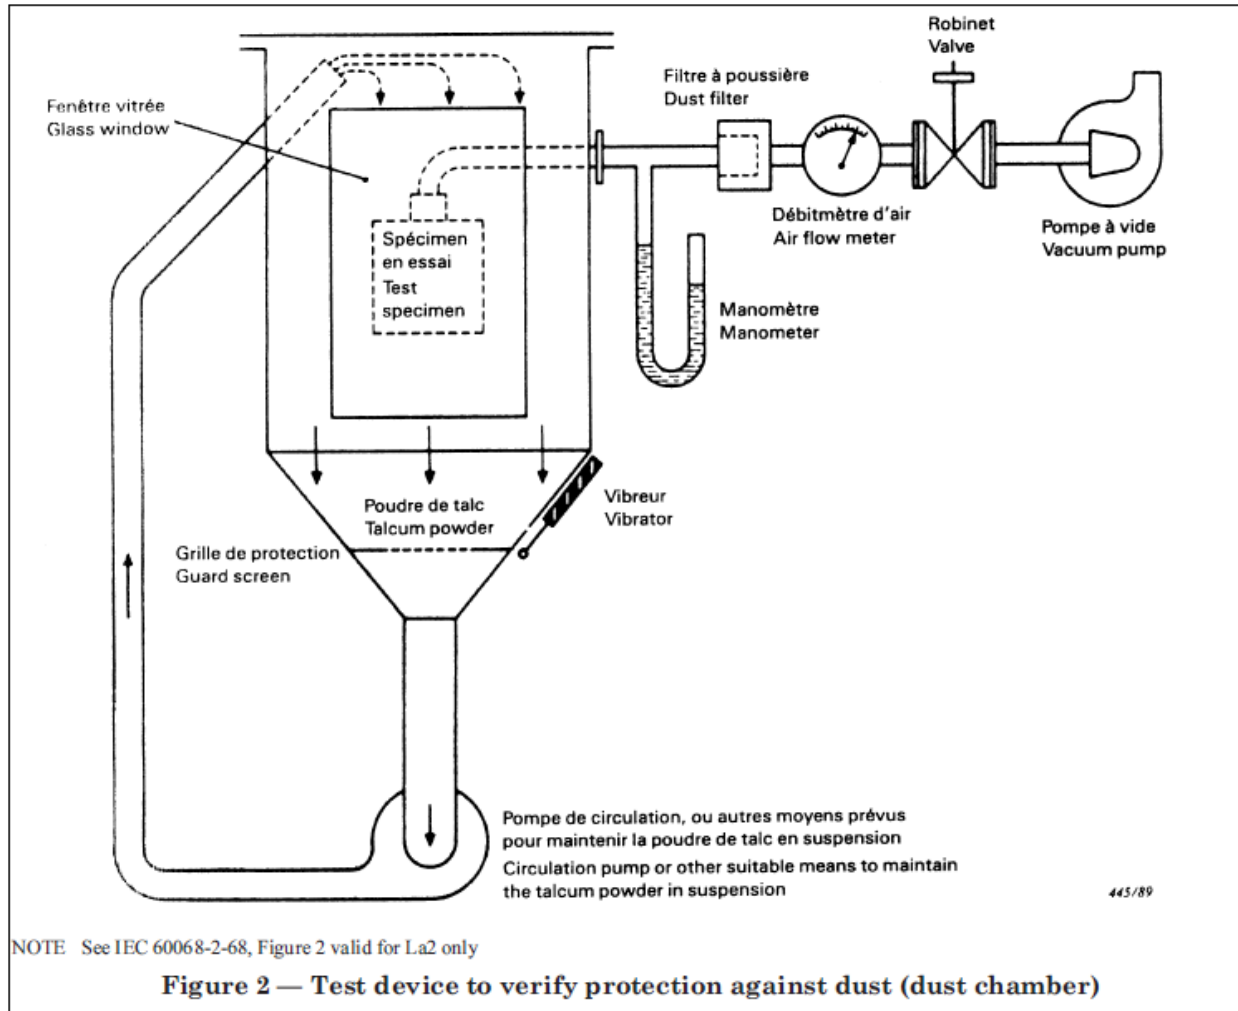
Figure 2: IP Dust Rig Schematic

The chamber used for the dust test is constructed according to the British Standard BS EN 60529:1992+A2-2013. A schematic diagram of this chamber is reproduced in the figure below.

Circulation and suspension of the 50-micron powder (magnesium silicate) was achieved by the use of two methods: a centrifugal fan piped to the hopper and taking the dust to the top of the construction, and an eccentric vibrator on one of the bottom sides of the construction to prevent settling.

This was a category 2 dust test, as the enclosure does not operate under vacuum. The duration of the test was 8 hours.

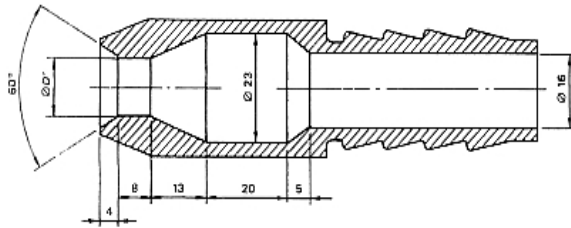
Figure 3: IPX5 Nozzle Schematic

The flow rate was 12.5 litres per minute \pm 5% through a 6.3mm diameter nozzle from a distance of 2.5 to 3 metres as specified by EN 60529:1992+A2-2013, section 14.2.5. The water was continually sprayed from all directions.

A schematic of the nozzle is given below together with a photo of the nozzle used.

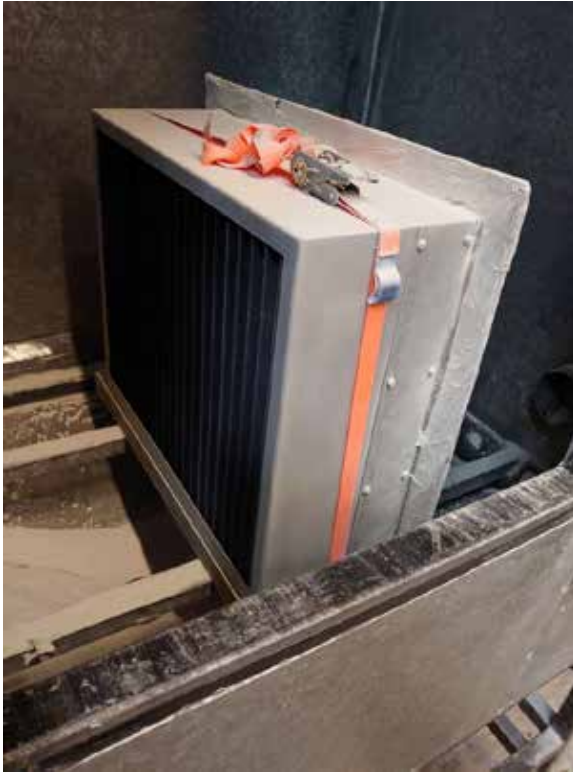
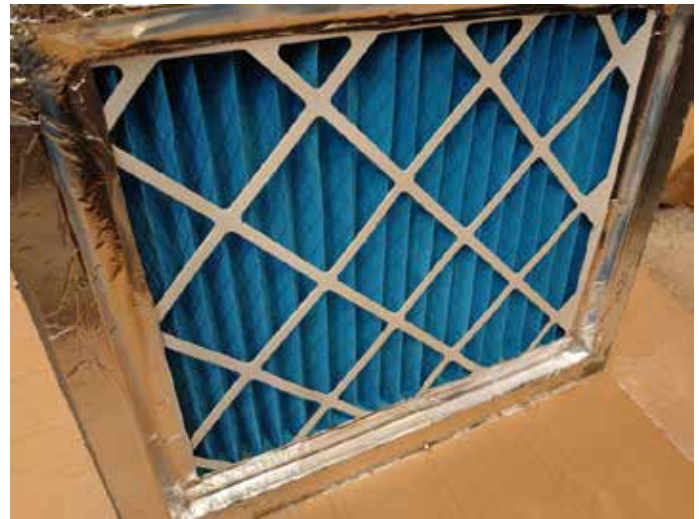
Figure 5: Dust Ingress

After removing the louvre from the dust chamber and brushing down, the unit was opened to ascertain whether there had been any ingress of dust. The figures below show that no dust ingress occurred.

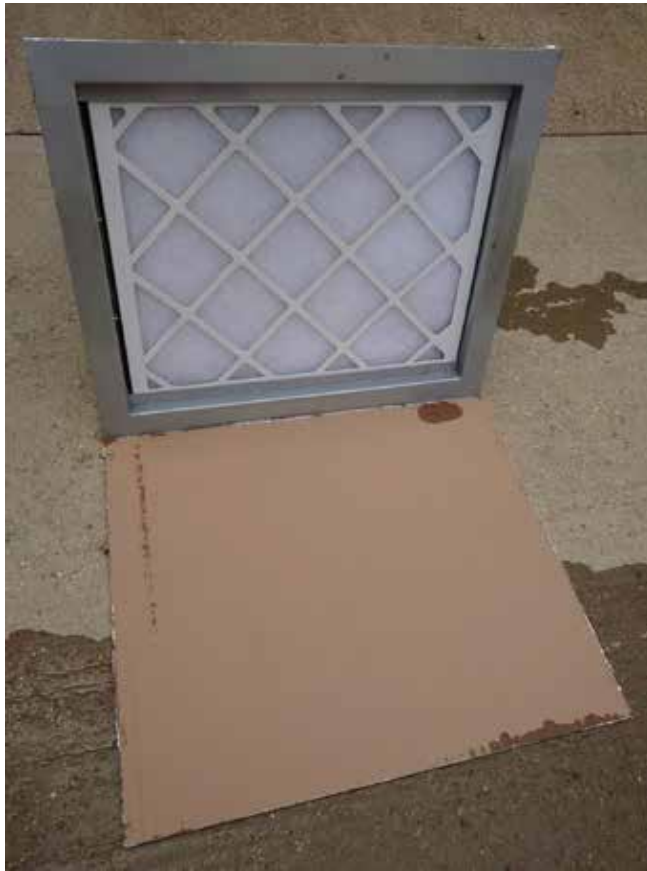
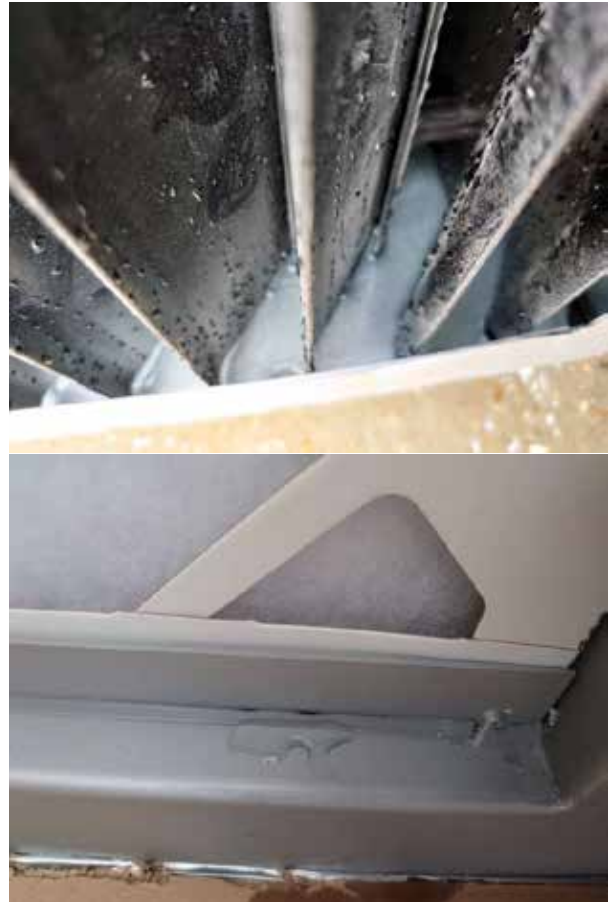
Figure 6: Water Test

After wiping down the excess water from the louvre enclosure the cardboard back plate was opened to evaluate whether there had been any ingress of water. Examination showed that a small quantity of water had occurred, upon closer inspection this was due to the silicon seal not being correctly applied.

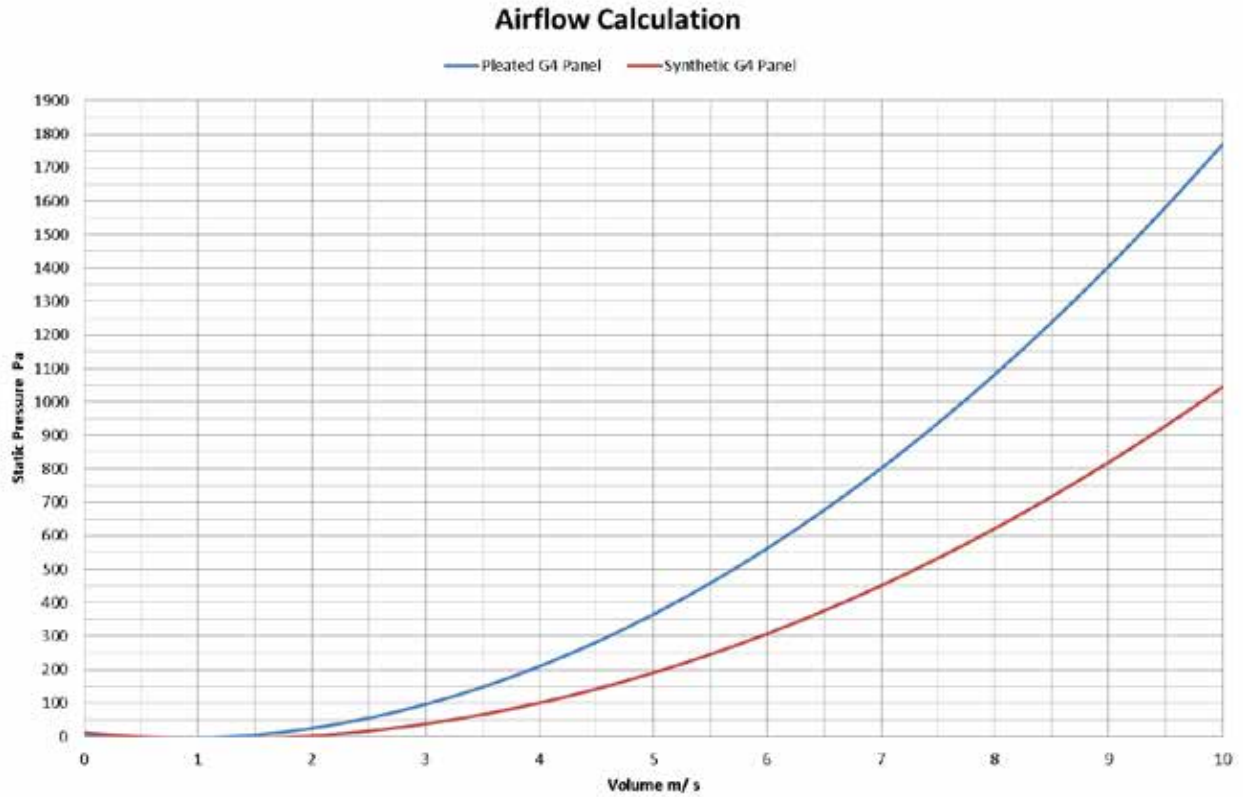
Figure 7: Pressure Drop Test

After both the dust and water tests, the louvre was subjected to a pressure drop test which was requested by Spraydown.

The graph below has been extrapolated based on existing trends from CRT test data.

The louvre was fitted into a plenum box and connected to CRT's airflow test rig, the largest rig was used for this test to provide the maximum obtainable airflow. The pipe diameter was 15" with an orifice plate of 11.25".

Using this method air was drawn into the rig by a fan downstream of the orifice plate. Pressure was measured across the orifice plate using inverted manometers and converted to a volumetric airflow using a standard equation. A second manometer measured the pressure drop across the louvre.
