CD85

INDUSTRIAL DEHUMIDIFIER

OWNER'S MANUAL

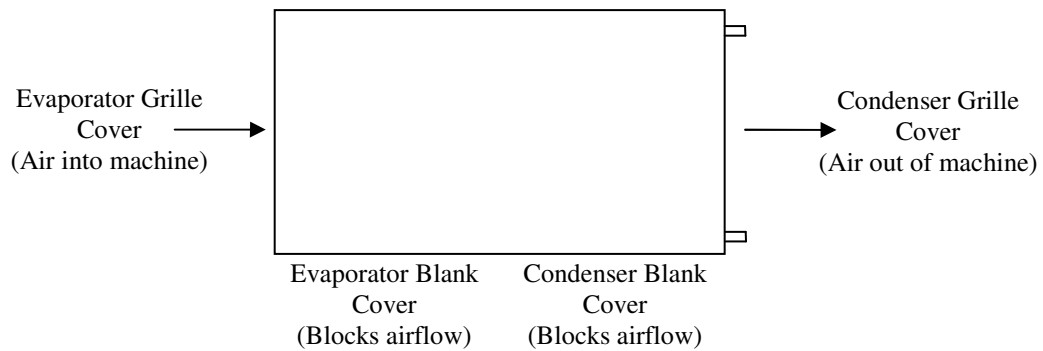
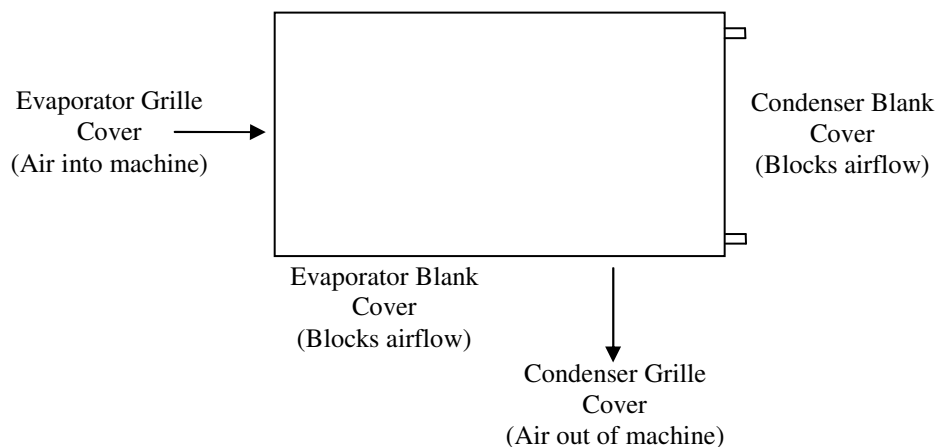
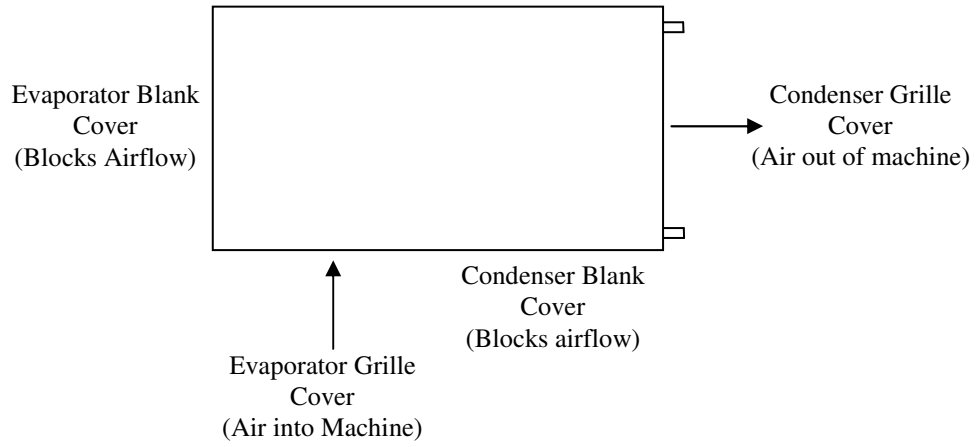
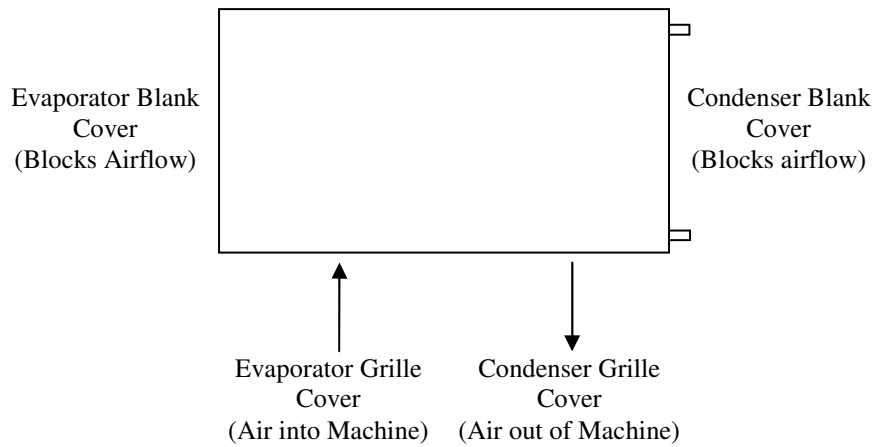
The CD85 covers can be swapped to allow the airflow direction to be changed to better suit the application the unit is to be used for. To change the covers, first remove the 4 off retaining screws and washers from each cover, swap cover positions and replace 4 off retaining screws and washers. If changing the evaporator covers then the filter retaining mesh should always be placed behind the Evaporator Grille Cover. This is held in place with 4 off M3 hex head bolts. For correct installation and operation the unit inlet and outlet must have a clearance of 0.5M from all adjacent surfaces and or structures. Evaporator Grille Cover and Evaporator Blanking Cover are interchangeable. Condenser Grille Cover and Condenser Blanking Cover are interchangeable. Evaporator and Condenser covers are not interchangeable. The different combinations available are shown below.
